**Flood Control Project Maintenance  
Levee Inspections**  
**LMA District Cover Sheet**  
**Spring 2008 Levee Inspection Results**

**Reclamation District No. 0003**

**Levee Inspection Report By Mile - Spring 2008**

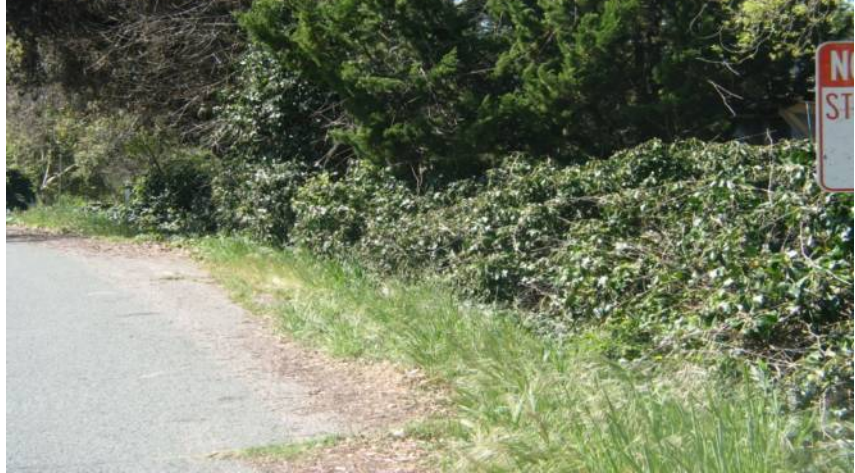
Levee Mile Report Line	6
Start Levee Mile	0.22
End Levee Mile	0.28
Location	
Category	Earthen Levee
Item	Encroachments
Dense landscaping on waterside from LM 0.22 to 0.28

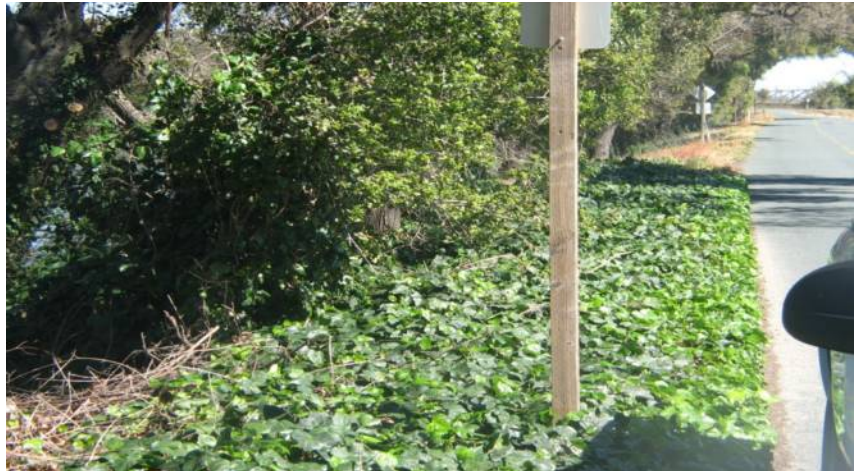
Levee Mile Report Line	6
Start Levee Mile	0.22
End Levee Mile	0.28
Location	
Category	Earthen Levee
Item	Encroachments
Looking upstream at dense landscaping on waterside slope from LM 0.22 to 0.28

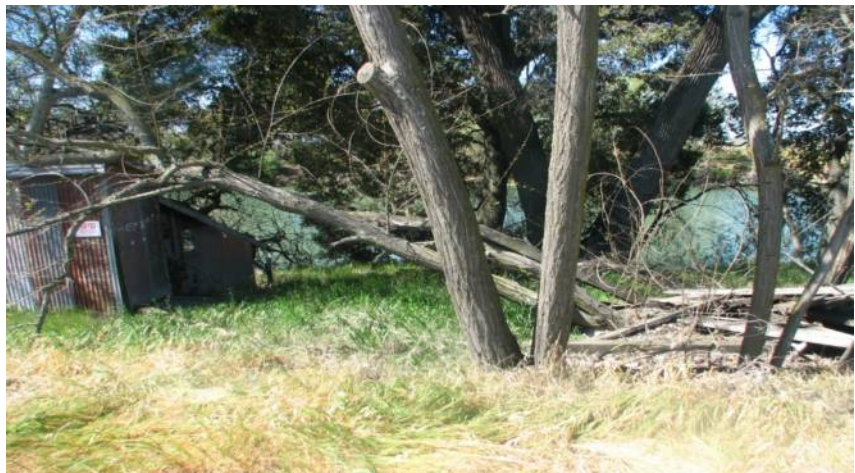
Levee Mile Report Line	9
Start Levee Mile	0.58
End Levee Mile	0.58
Location	
Category	Earthen Levee
Item	Encroachments
Down tree limbs on waterward slop at LM 0.58

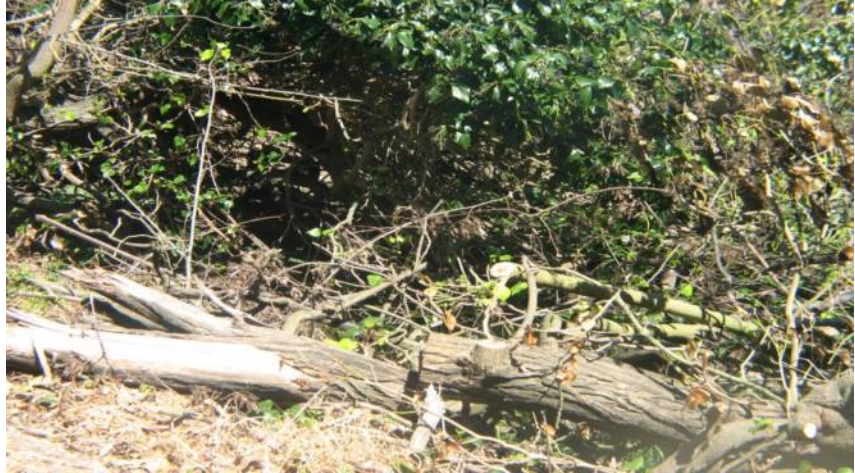
Levee Mile Report Line	12
Start Levee Mile	1.08
End Levee Mile	1.09
Location	
Category	Earthen Levee
Item	Trim / Thin Trees
Down tree limbs on landside slope from LM 1.08 to 1.09

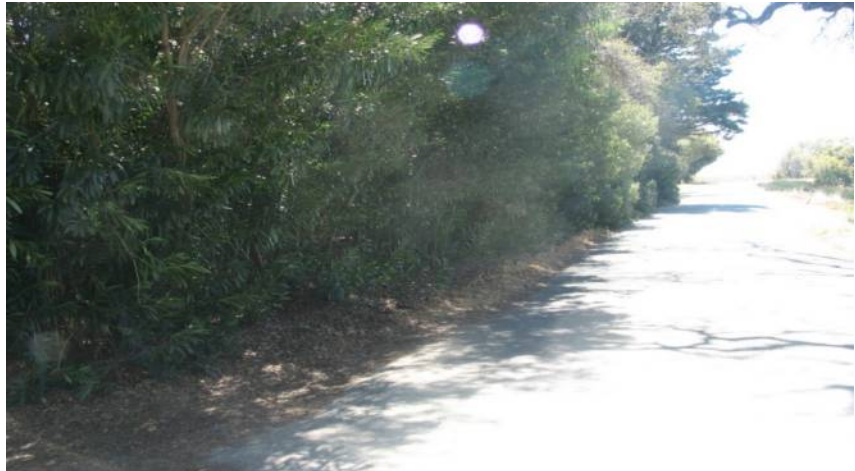
Levee Mile Report Line	13
Start Levee Mile	1.21
End Levee Mile	1.27
Location	
Category	Earthen Levee
Item	Encroachments
Landscaping on landside slope block view of levee from LM 1.21 to 1.27

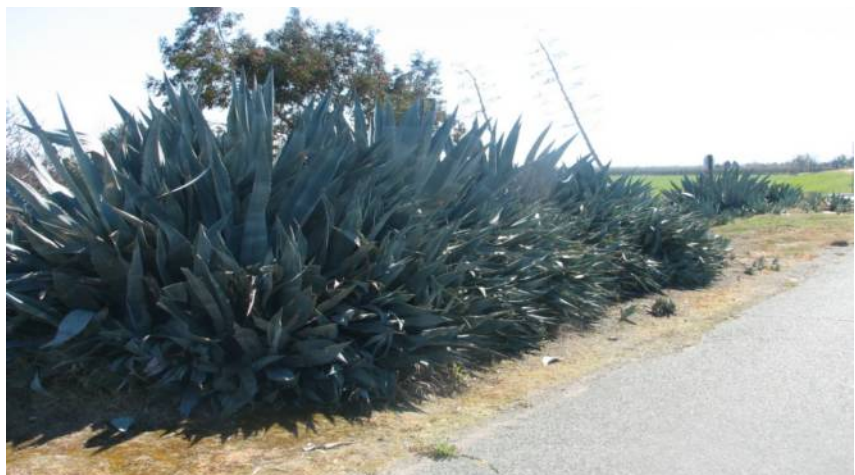
Levee Mile Report Line	23
Start Levee Mile	7.08
End Levee Mile	7.10
Location	
Category	Earthen Levee
Item	Encroachments
Large Cactus plant on landside shoulder block view of levee slope from LM 7.08 to 7.10

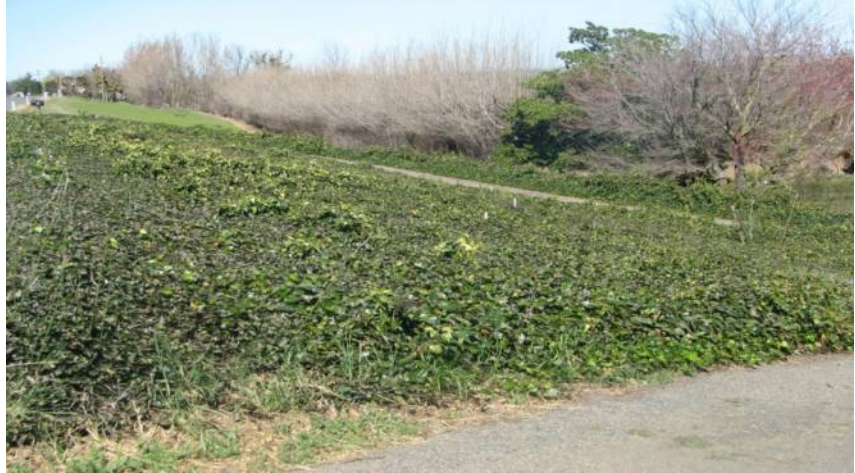
Levee Mile Report Line	25
Start Levee Mile	7.95
End Levee Mile	8.00
Location	
Category	Earthen Levee
Item	Encroachments
Landscaping (Ivy) on landside slope blocking view of levee from LM 7.95 to 8.00

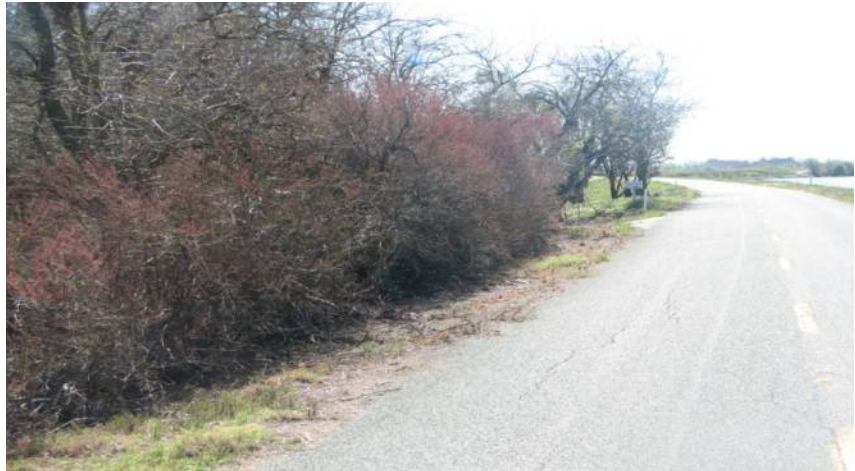
Levee Mile Report Line	27
Start Levee Mile	10.20
End Levee Mile	10.22
Location	
Category	Earthen Levee
Item	Trim / Thin Trees
Tree to be trimmed on landside shoulder from LM 10.20 to 10.22

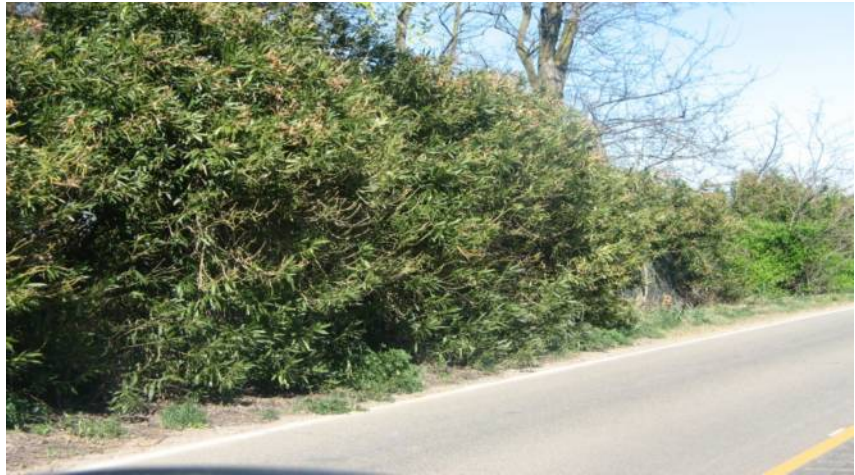
Levee Mile Report Line	11
Start Levee Mile	5.94
End Levee Mile	6.00
Location	
Category	Earthen Levee
Item	Encroachments
Oleander on landside shoulder blocking view of levee slope from LM 5.94 to 6.00

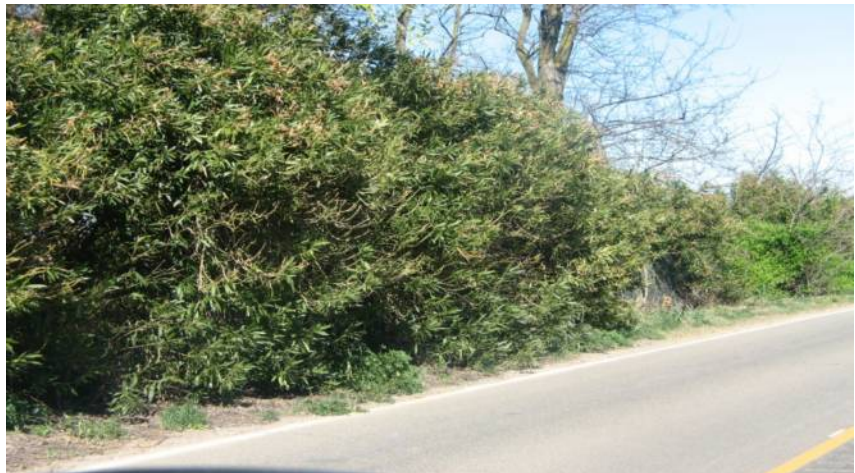
Levee Mile Report Line	11
Start Levee Mile	5.94
End Levee Mile	6.00
Location	
Category	Earthen Levee
Item	Encroachments
Oleander on landside shoulder blocking view of levee slope from LM 5.94 to 6.00

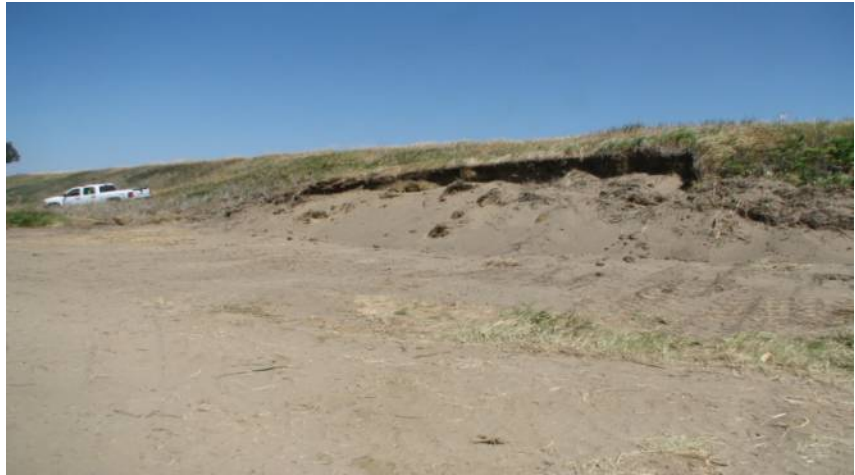
Levee Mile Report Line	13
Start Levee Mile	7.27
End Levee Mile	7.27
Location	
Category	Earthen Levee
Item	Slope Stability
View looking upstream at material removed for landward slope at LM 7.27

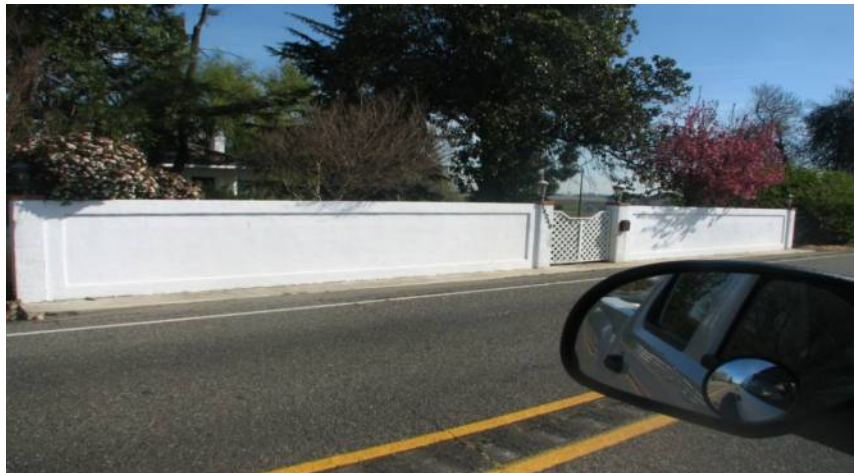
Levee Mile Report Line	20
Start Levee Mile	10.13
End Levee Mile	10.13
Location	
Category	Earthen Levee
Item	Encroachments
Block/Concrete fence on landside shoulder at LM 10.13

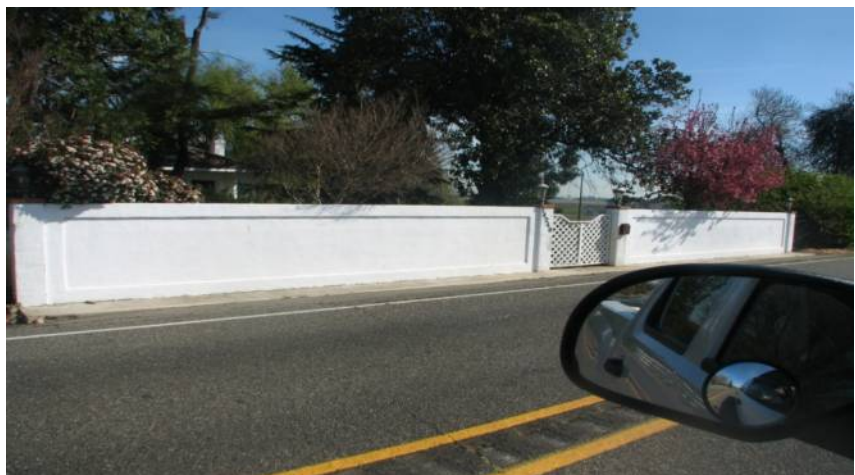
Levee Mile Report Line	20
Start Levee Mile	10.13
End Levee Mile	10.13
Location	
Category	Earthen Levee
Item	Encroachments
Block/Concrete fence on landside shoulder at LM 10.13

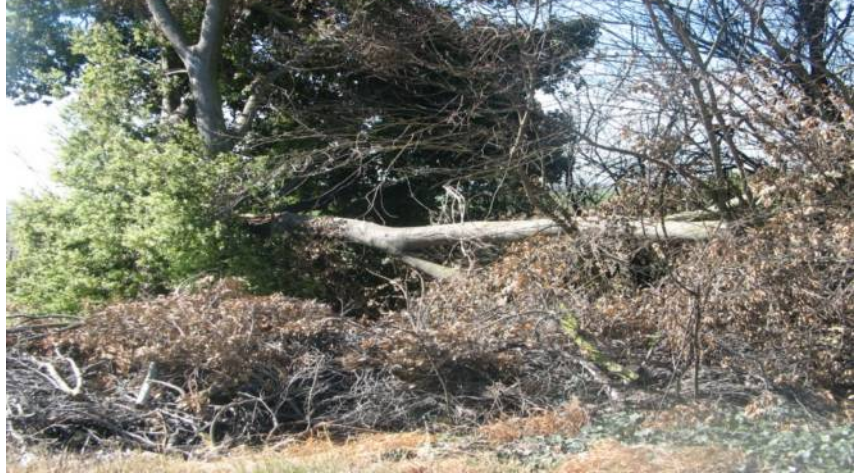
Levee Mile Report Line	59
Start Levee Mile	15.83
End Levee Mile	15.83
Location	
Category	Earthen Levee
Item	Encroachments
Down tree limbs on landside slope at LM 15.83

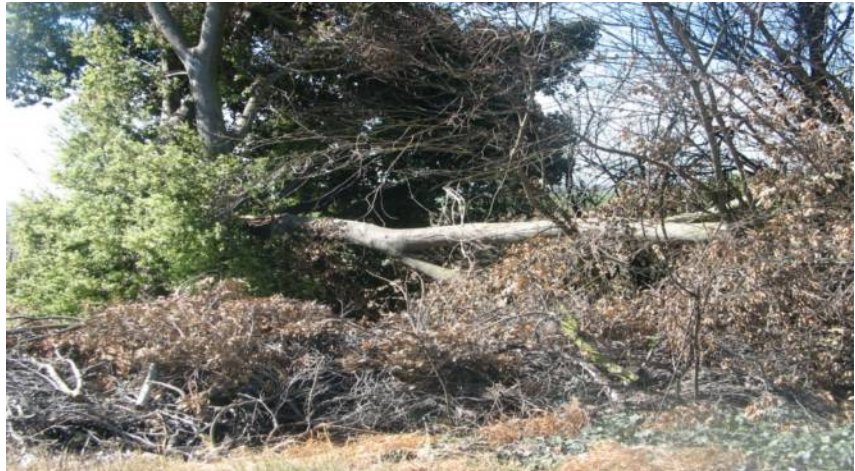
Levee Mile Report Line	59
Start Levee Mile	15.83
End Levee Mile	15.83
Location	
Category	Earthen Levee
Item	Encroachments
Down tree limbs on landside slope at LM 15.83
